Green Acres

Construction Services, a Tecta America company, installs a vegetative roof system on the Birmingham SSA Center

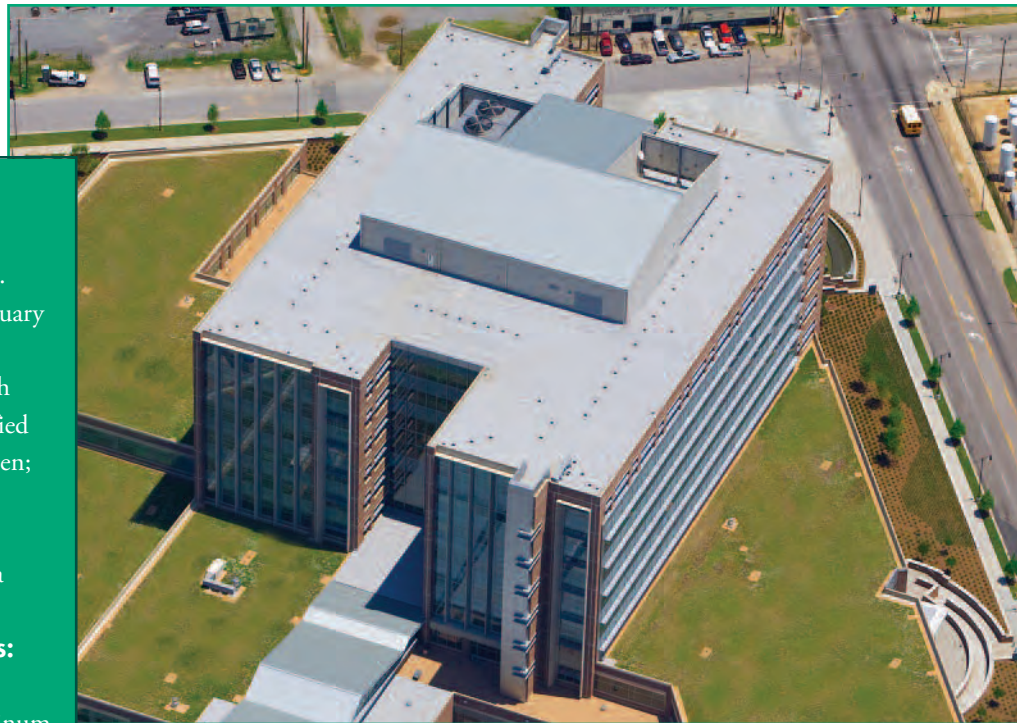
More than 1,000 cubic yards of growing medium and more than 160,000 sedum plants were installed on the building's second-floor rooftop.

Next, more than 1,000 cubic yards of growing medium and more than 160,000 sedum plants were hoisted to the roof and installed.

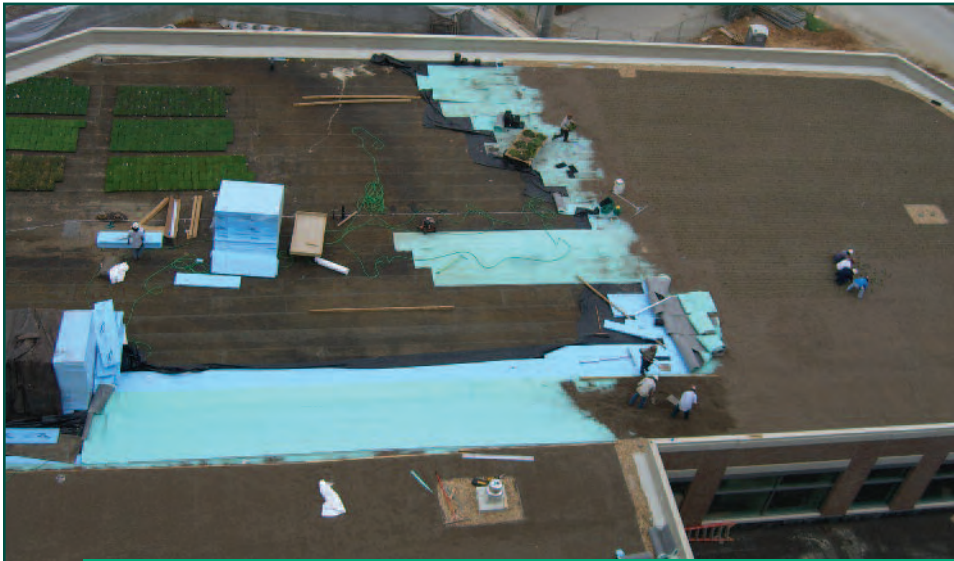
Top: Before installing the overburden, Construction Services loose-laid a polypropylene composite with a drainage core and a water-retention fabric on one side on the waterproofed deck. Bottom: The completed Birmingham Social Security Administration Center has achieved LEED® Silver Certification.

Styrofoam™ Plazamate insulation. The crew then loose-laid Colbond Inc.’s EnkaRetain & Drain, a post-industrial recycled polypropylene composite with a drainage core and a water-retention fabric on one side, on the waterproofed deck.
